**INITIAL SITE CHARACTERIZATION
AND
SUBSURFACE INVESTIGATION REPORT**

**4TH AND GAMBELL
ANCHORAGE, ALASKA**

4th & Gambell Site Investigation - DRAFT

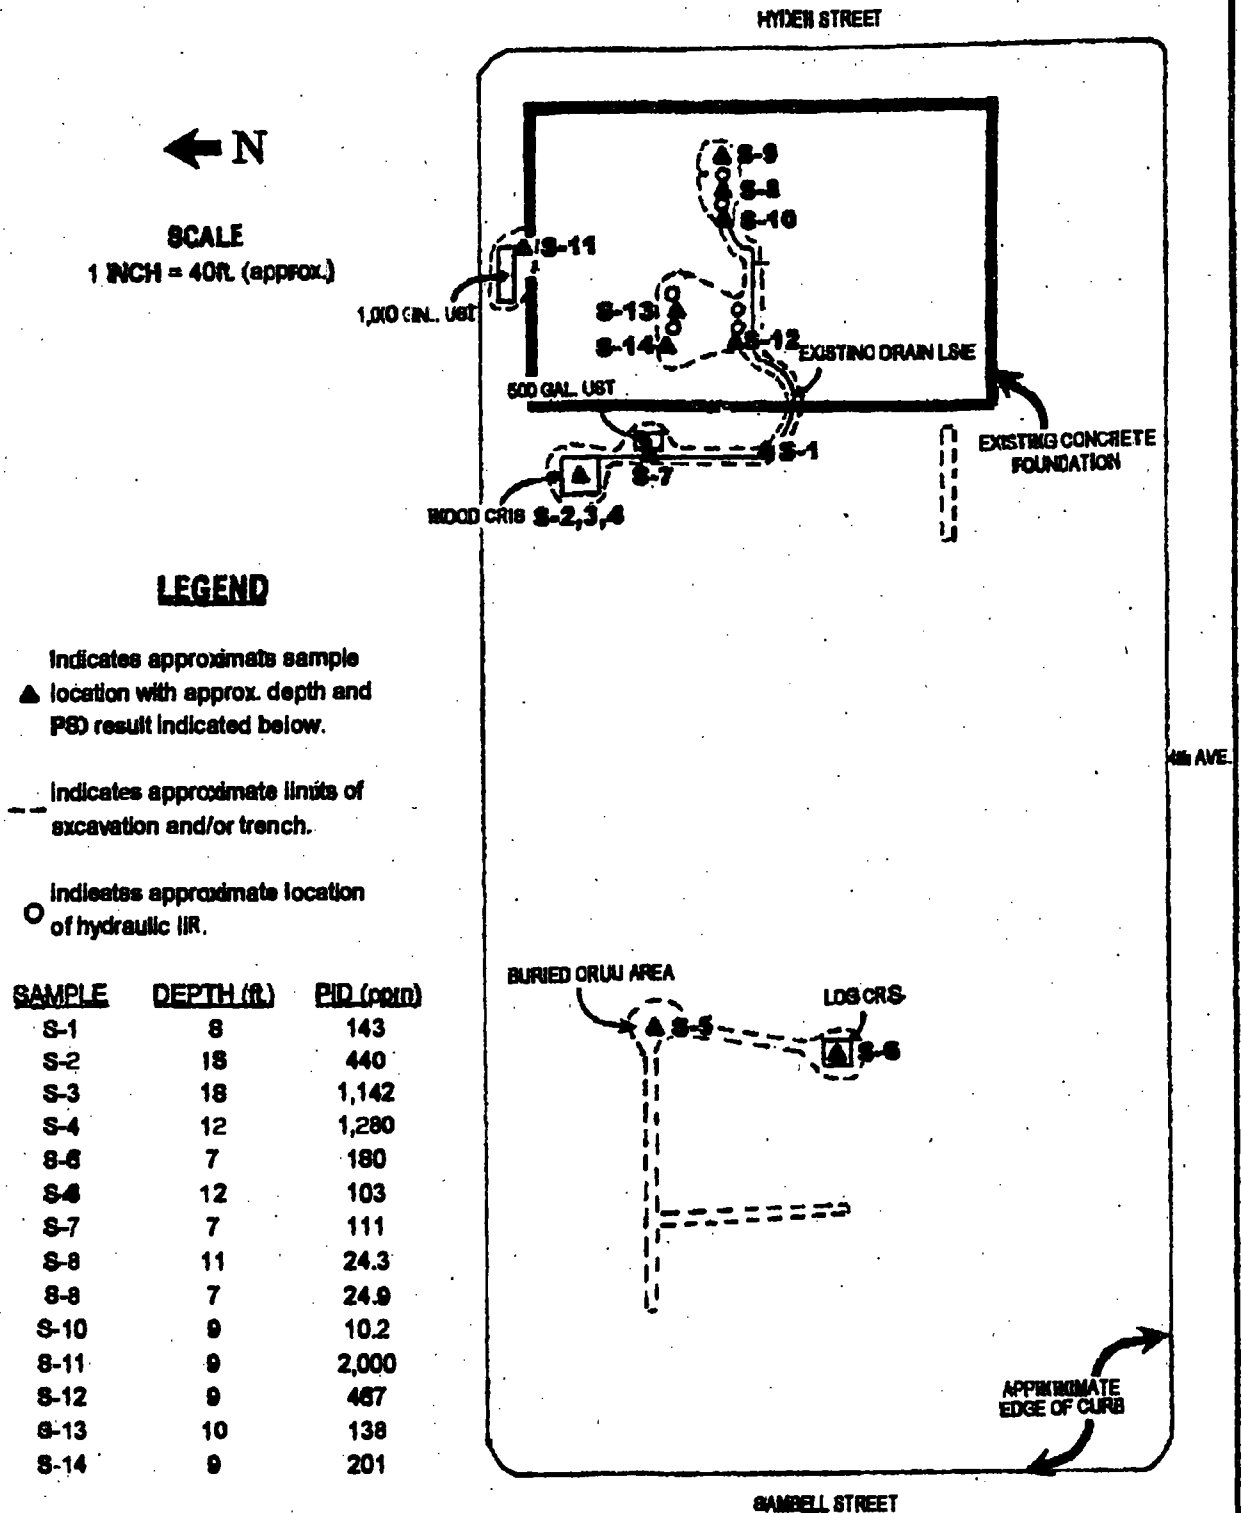
FIGURE 2

Seven soil samples were collected and field screened in the areas of the piping and the hoists. The approximate sample locations are shown in Figure 2. The depth of the sample and the corresponding PID reading is also recorded on the Figure. The samples are S-8, S-9, S-10, S-12, S-13, and S-14. The six samples were analyzed by Wy'East Environmental Sciences of Portland, Oregon. The soils were tested for total petroleum hydrocarbon content. The sampling protocol can be reviewed in Appendix F. Tables in Appendix C provide the laboratory results as well as the corresponding PID readings for each sample. The laboratory report can be reviewed in Appendix D.

Three of the six samples collected in the area of the hydraulic lifts and associated piping had detectable levels of hydrocarbon. The levels ranged from 253 parts per million (ppm) to 4,830 ppm. At this time, we are estimating that approximately 100 cubic yards of soil may be contaminated with heavy oil.
